Navajo Abandoned Uranium Mine

Site Screen Report

Montezuma Creek AUM Site

August 2010

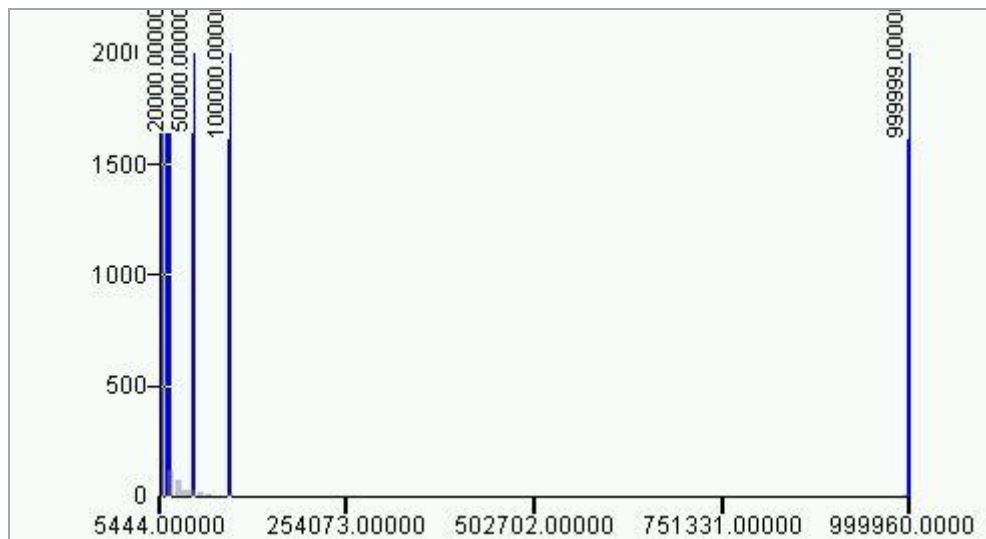
The following chart and statistics were generated by ESRI ArcGIS 9.3.1, and show the general distribution of the site gamma radiation measurements. The horizontal X axis represents the gamma radiation reading levels in cpm (lowest levels to the left). The vertical Y axis represents the frequency of each gamma radiation level.

Count:	2164
Minimum:	5444.00000
Maximum:	999960.00000
Sum:	51482914.00000
Mean:	23790.62569
Median:	11717.50000
Standard Deviation:	84844.89335

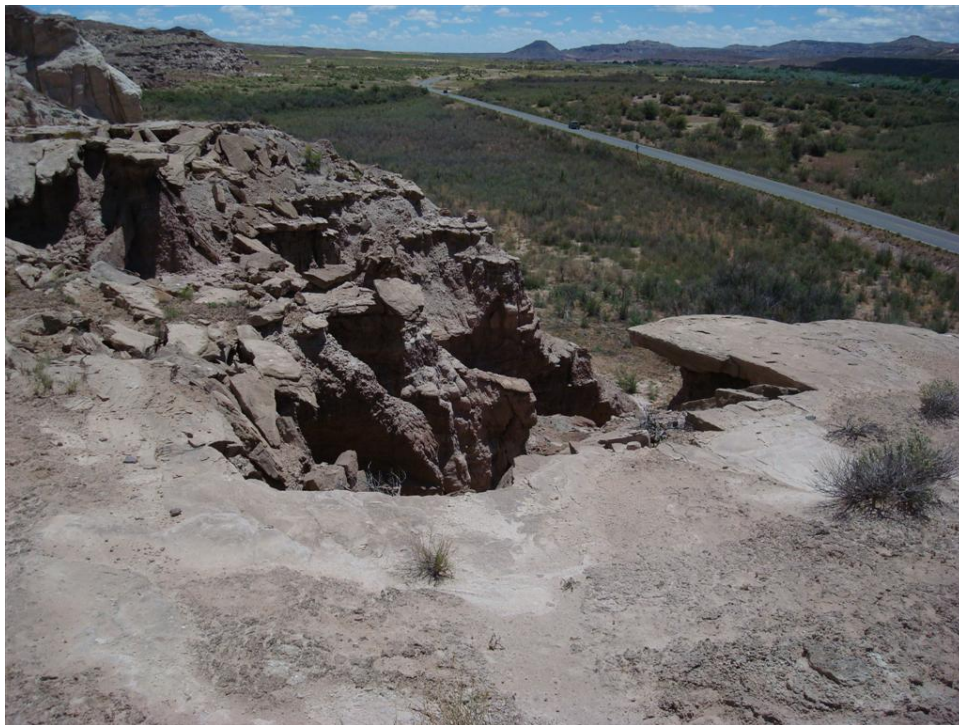
Photo 1. Montezuma Creek site, Highway 162 and San Juan River in the distance

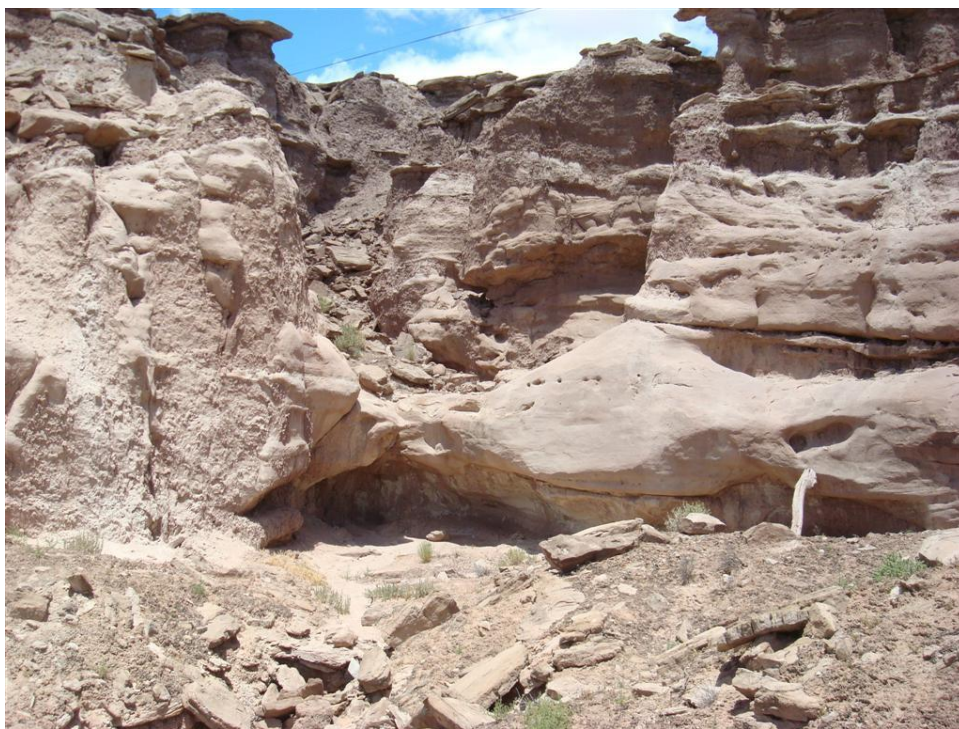
Small waste pile approx 20 yd³ at eastern cut

2 small cuts with dirt pushed against it

Photo 2. Montezuma Creek site

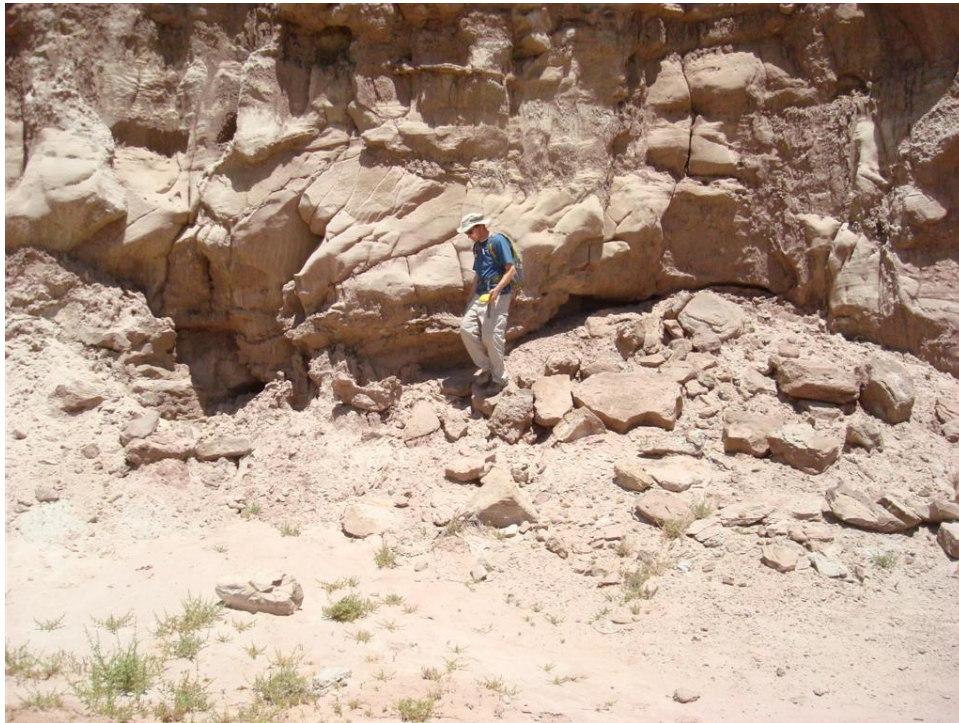
A total of 2,164 gamma radiation measurements were collected from the mine site, ranging from 5,444 cpm to 999,960 cpm. Measurements collected in the vicinity of the waste debris were found at levels up to approximately 1,000,000 cpm (the maximum gamma radiation level the equipment can detect). The measurements are represented in Figures 1 and 2.

Photo 3. Montezuma Creek site, area of highest readings

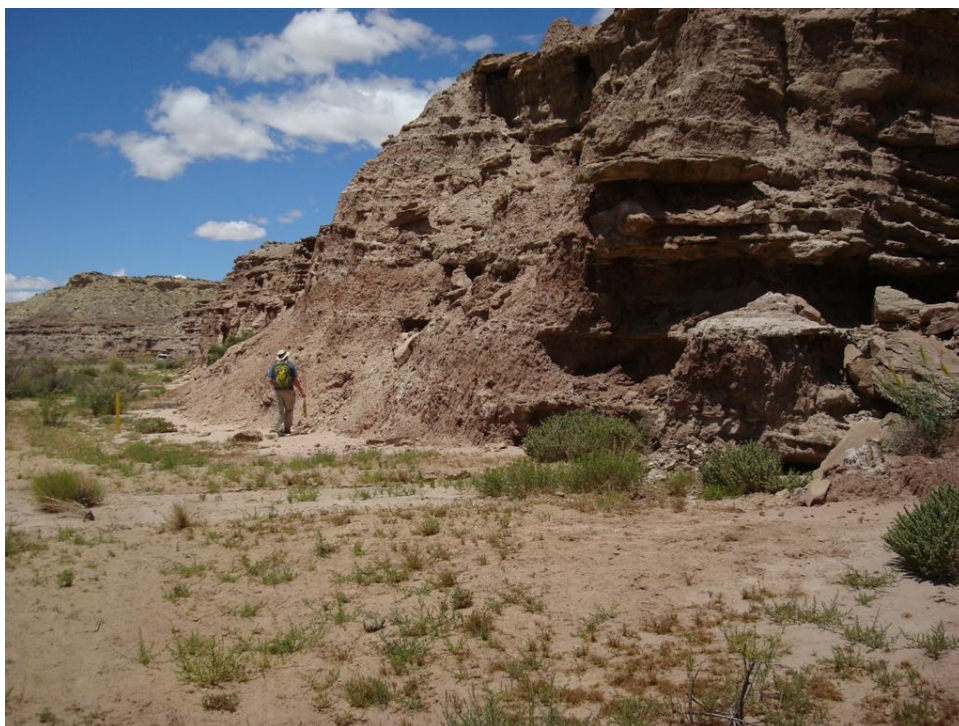
Photo 4. Montezuma Creek site

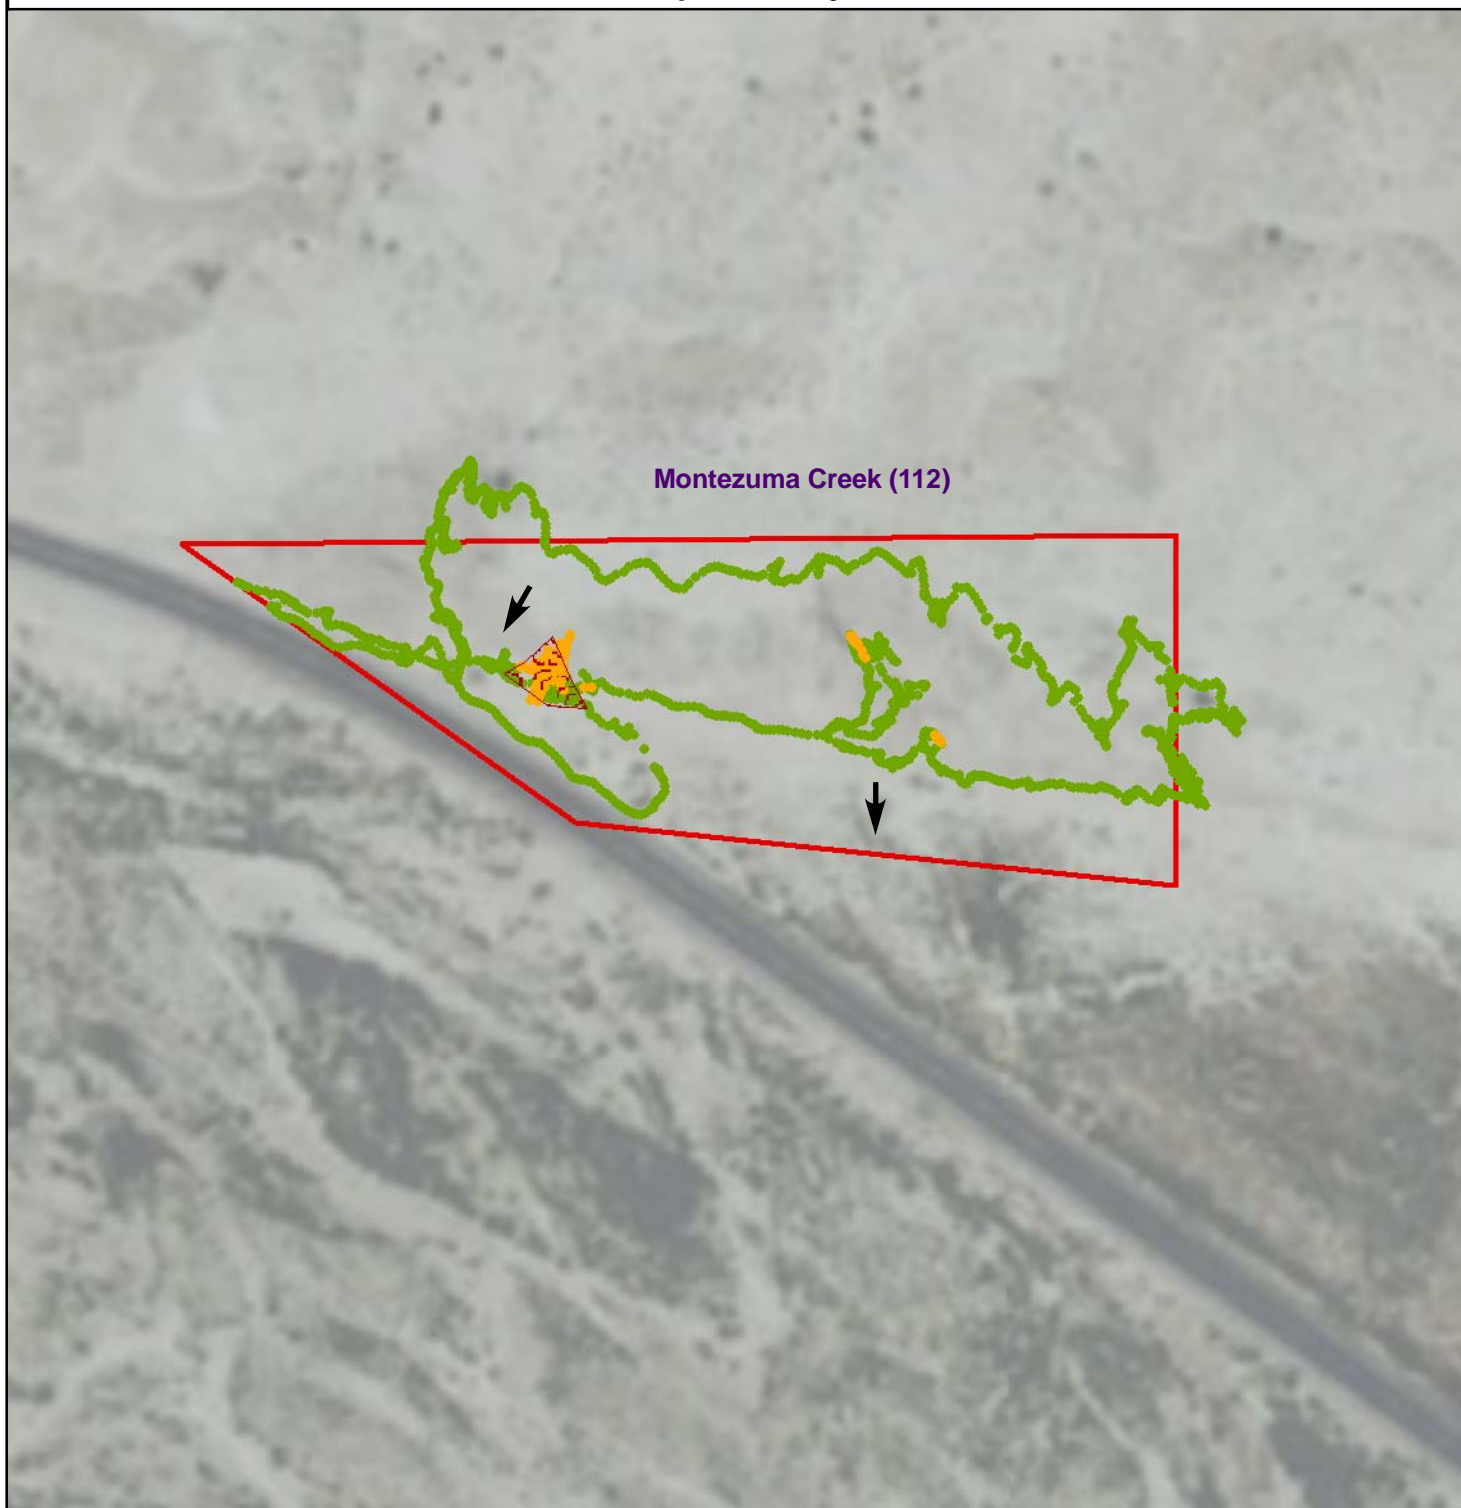
**Figure 1 - Gamma Radiation Measurements, Above Two Times Background
Montezuma Creek (112)
Aneth Chapter, Navajo Nation**

Gamma survey conducted 06/2010
Measured as counts per minute (cpm)

Average background = 8,853 cpm

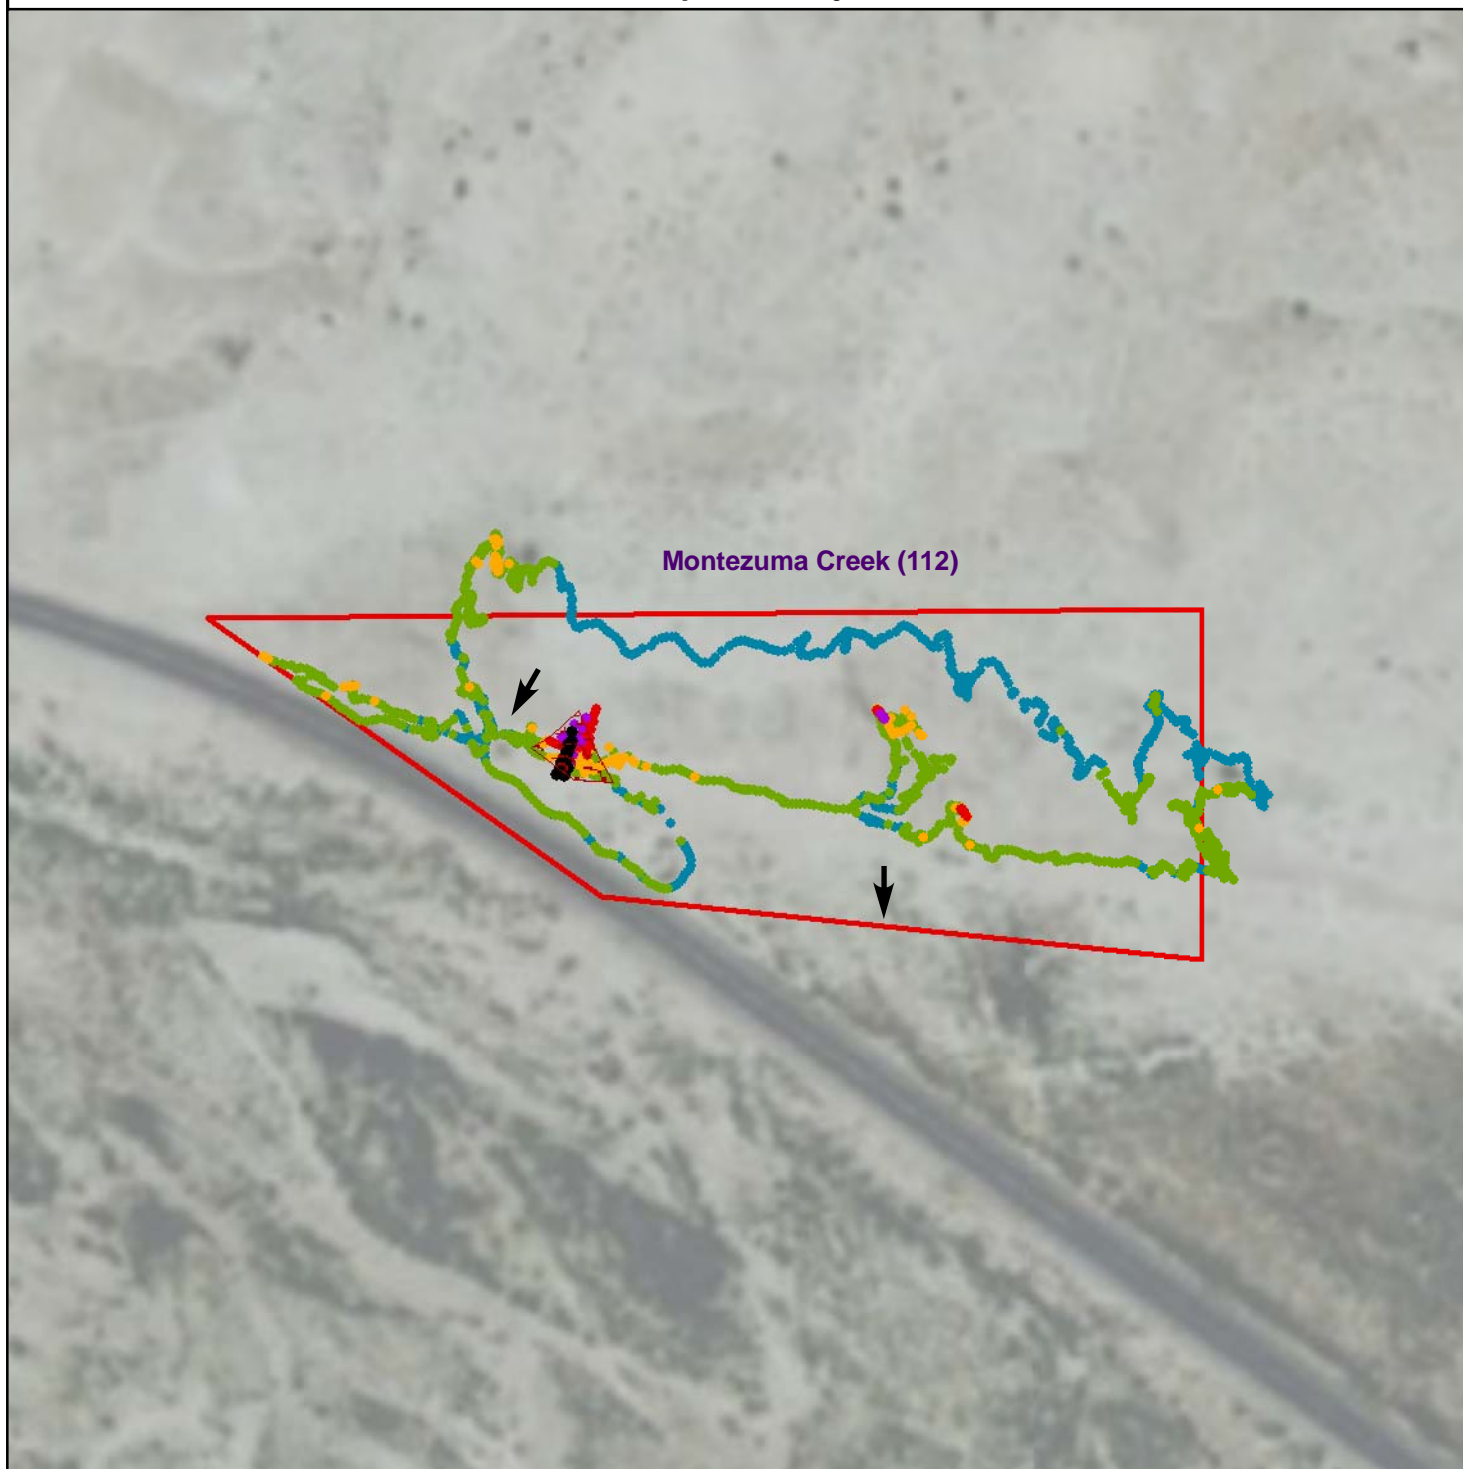
**Figure 2 - Gamma Radiation Measurements
Montezuma Creek (112)
Aneth Chapter, Navajo Nation**

Gamma survey conducted 06/2010
Measured as counts per minute (cpm)

Average background 8,853 cpm
